## Building design guide

# The Dragonfly Centre

Renovation of old store house to create office and exhibition space  
July 2009

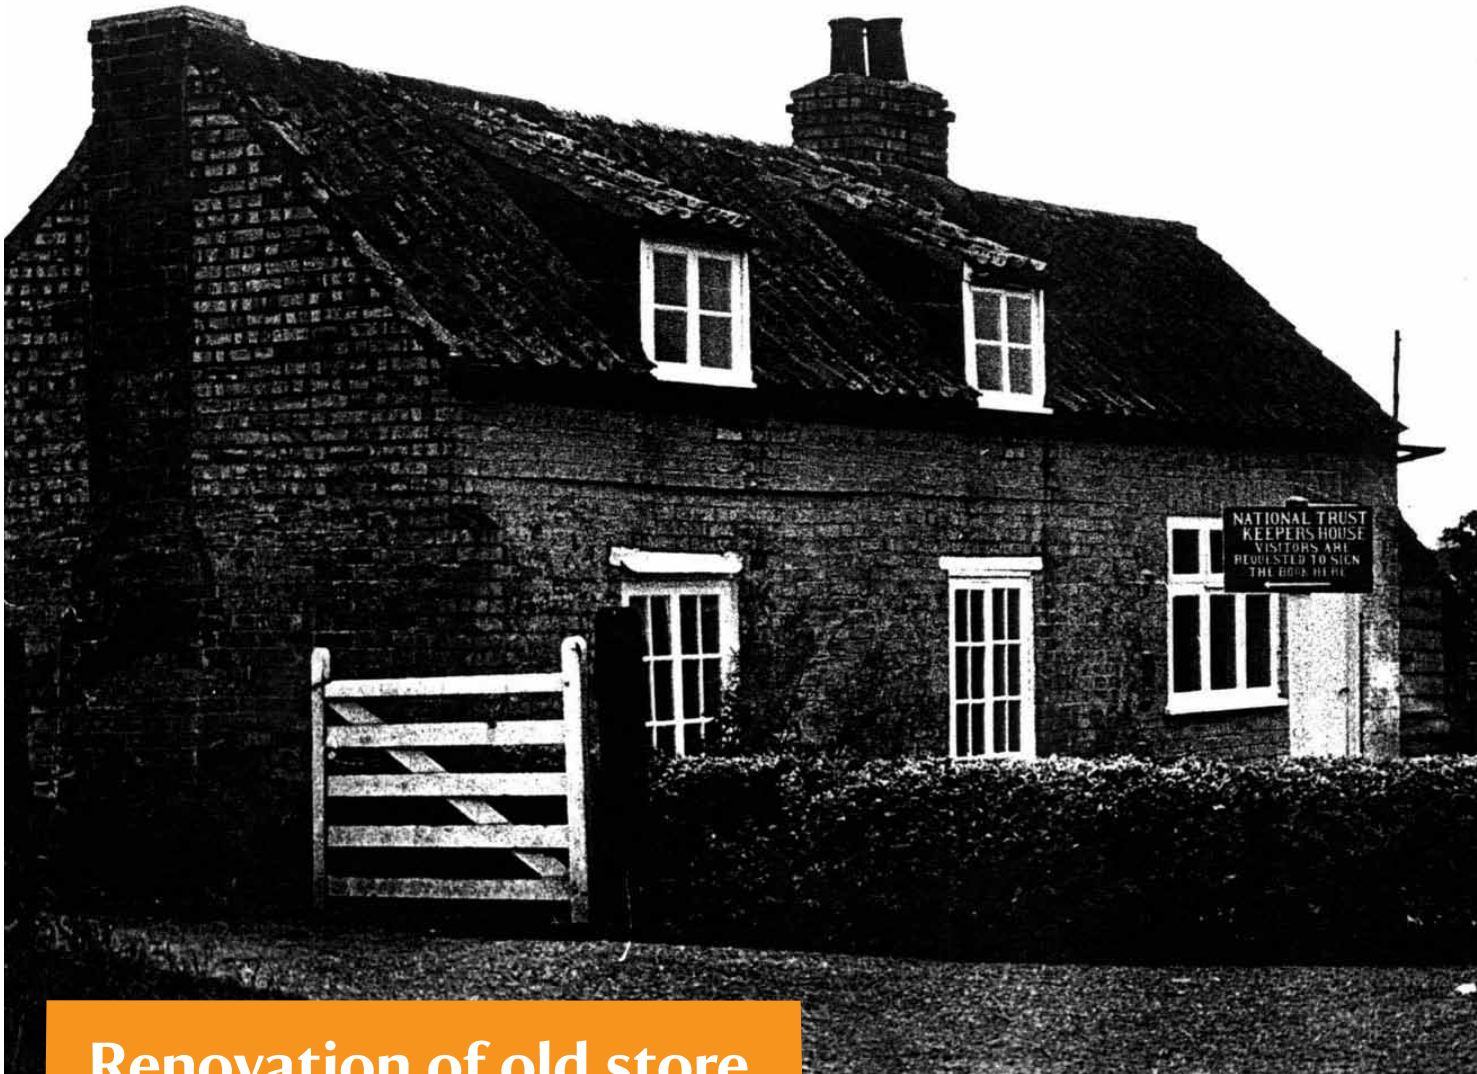
Above The 1950s reference photograph

It is therefore the main aim of this project to renovate the old store house to its 1950s state, so that it looks welcoming, helps create a link between the car park and the visitor building, and improves the initial experience of our supporters. Photographs from the 1950s will aid the renovation.

■ The windows, which were in a poor state of repair and between twenty and thirty years old, were replaced following the design of the ground floor pair shown in the historic photograph. The larger of the three windows was replaced to match the two smaller windows. It was more practical to have three matching windows produced. In addition, by reducing the size of the window a greater wall space could be achieved for the exhibition area.

■ The dormer windows as shown in the early photographs were recreated. It was not intended to replace the upper floors as the ceiling height would not be suitable for modern use. The interior remained full height, with the upper windows providing additional light.

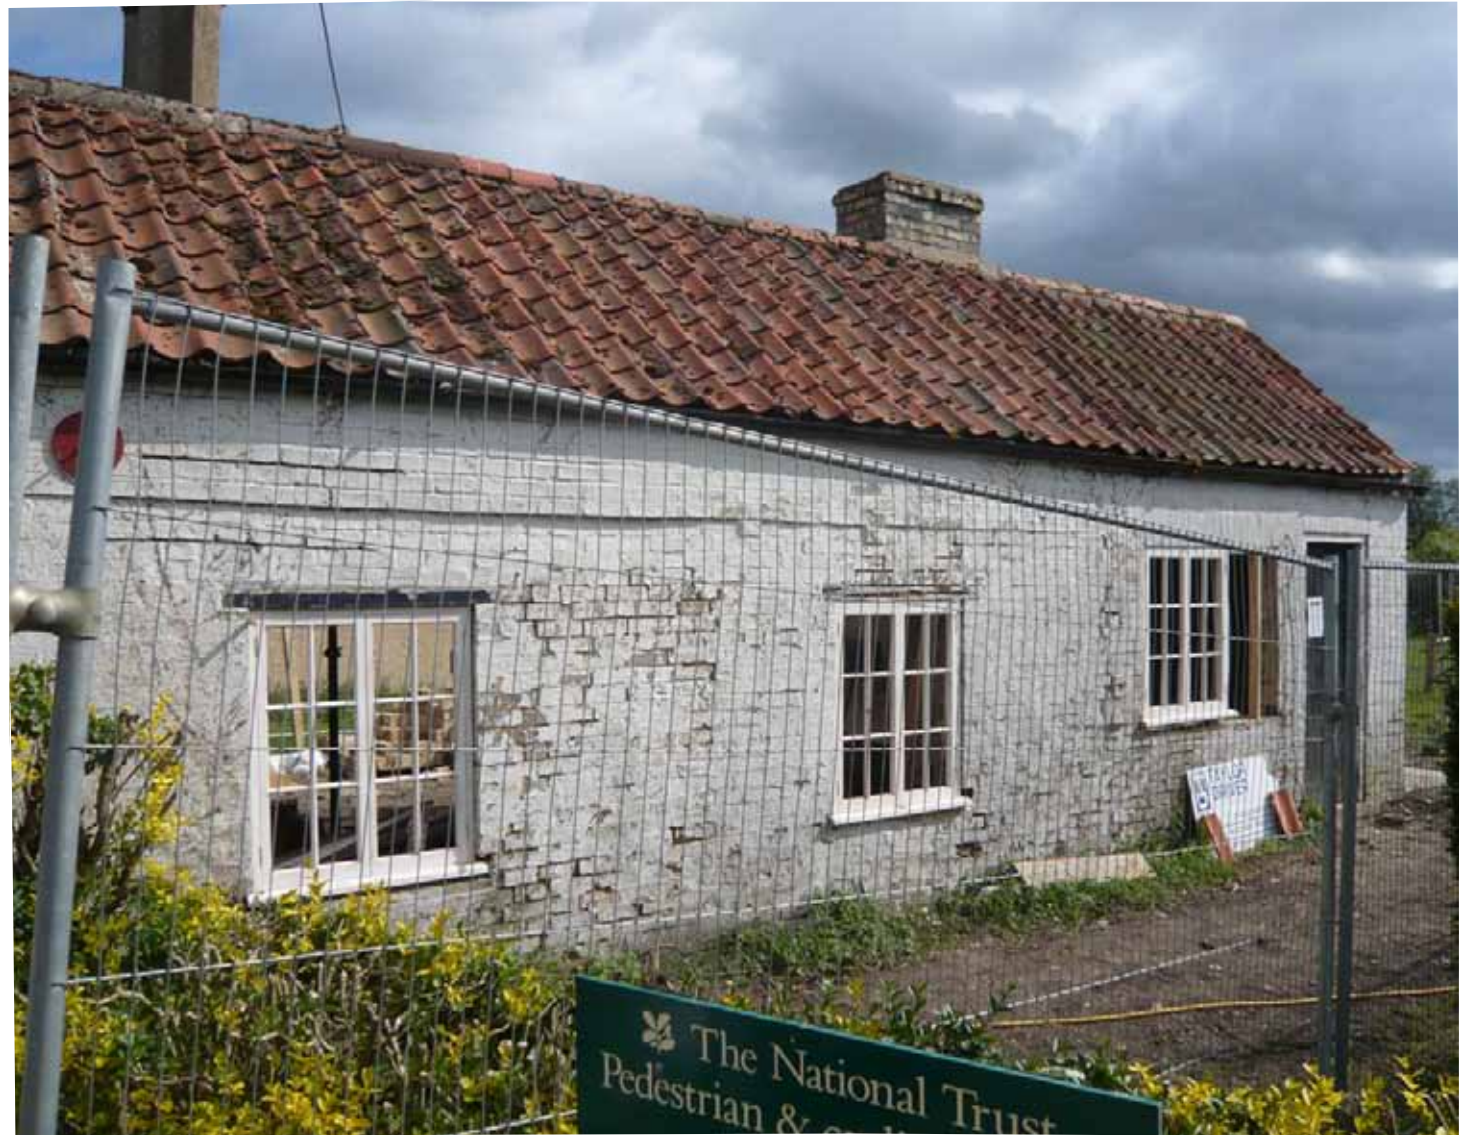
Above **Work in progress, fitting the new windows**

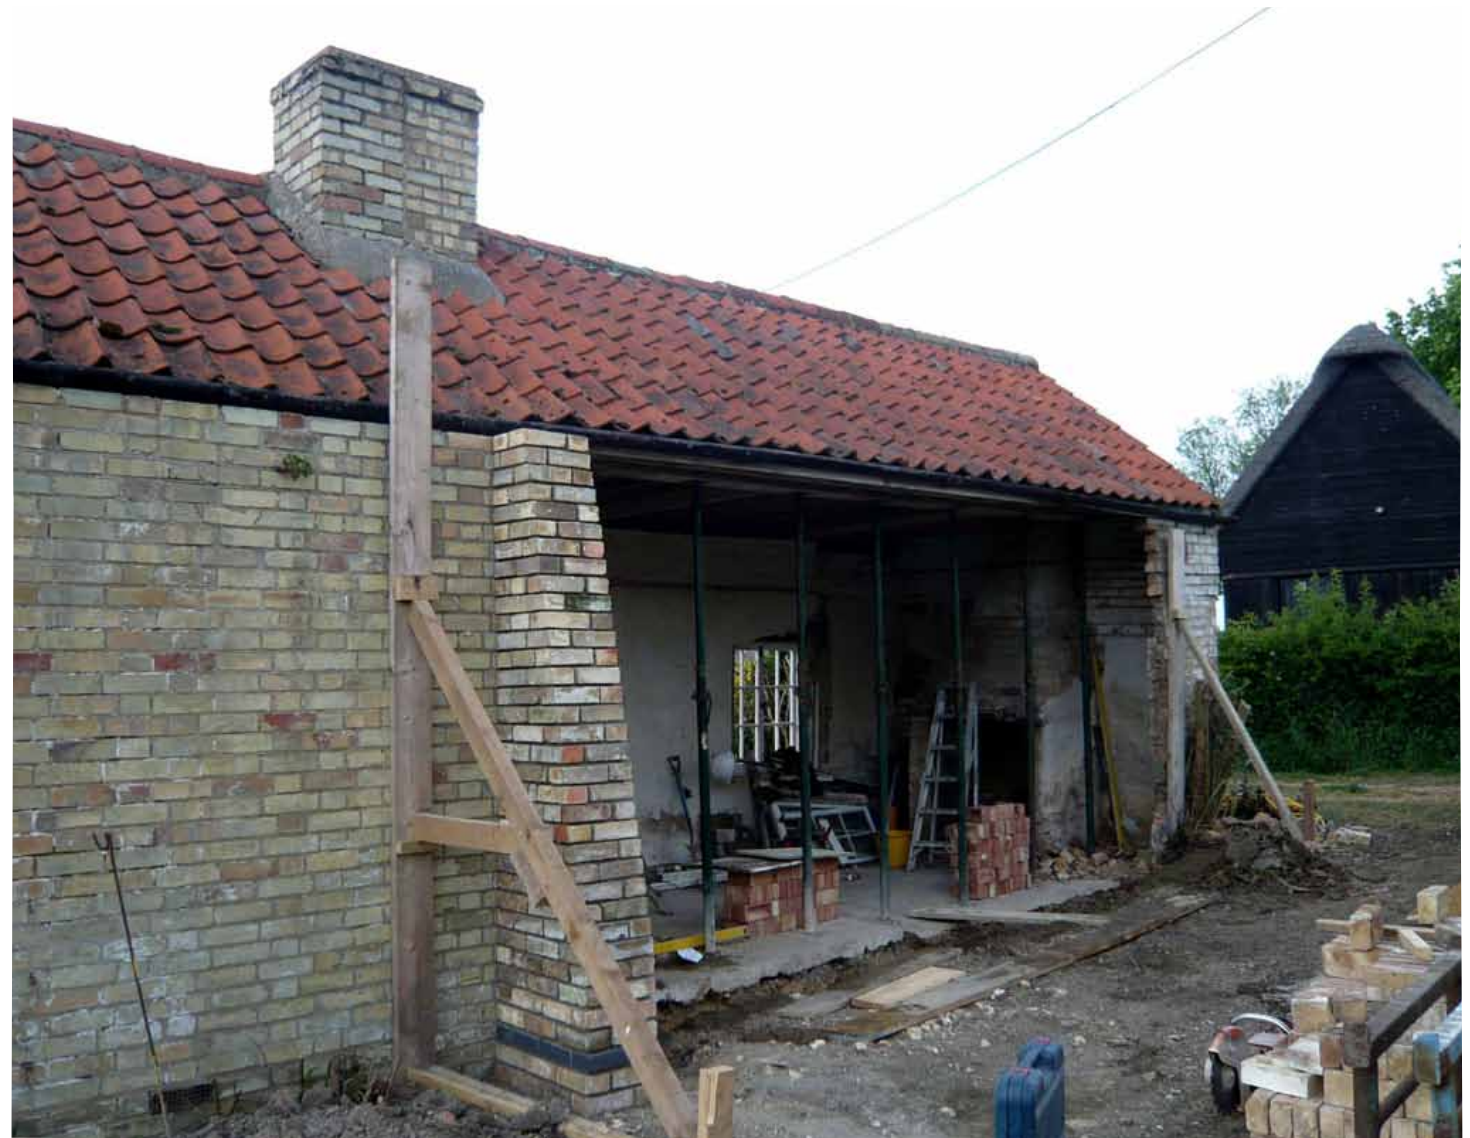
Above Rebuilding the rear wall, with new buttress

■ The poor quality of the original build has meant some extensive tying of brickwork in places to make it structurally sound. The single leaf brick rear wall was unstable. It had to be carefully demolished and a foundation put in. The wall was then replaced with a brick plinth and timber studwork finished with weather boarding. The other walls were stripped of the majority of the existing masonry paint and repainted using a lime-based paint in an off-white colour to match the nearby Fen Worker's Cottage.

- There were issues with a lack of foundations on the rear side requiring these to be installed along with the rebuilding of a new wall.

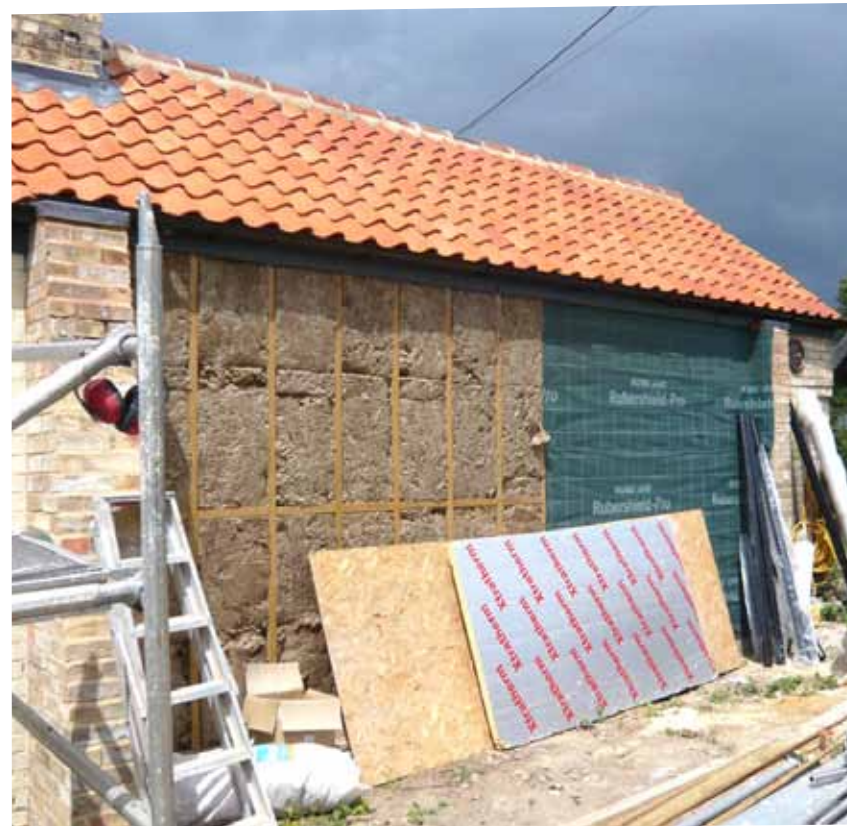
Left **Reconstructing the rear wall**

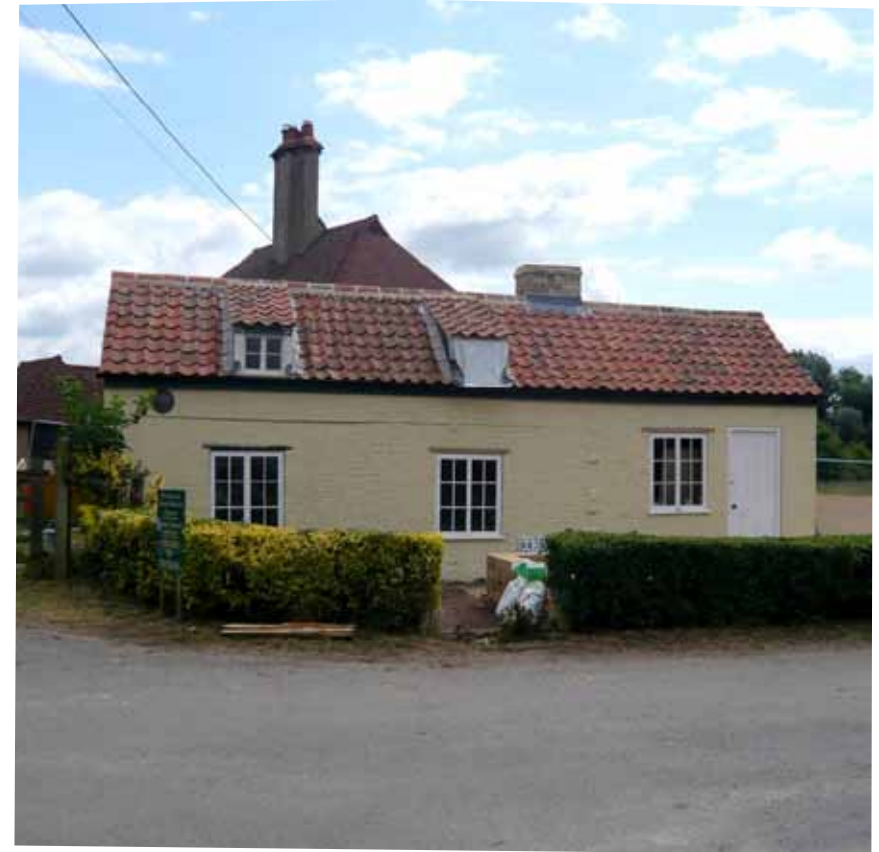
Top right **Work in progress, the larger window by the door has been replaced**

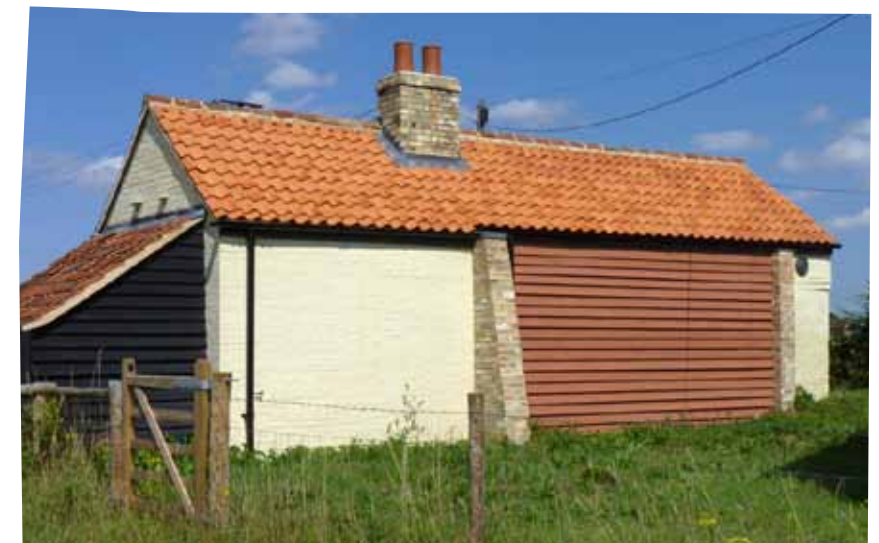
Right **The new rear wall, protected by weather boarding**

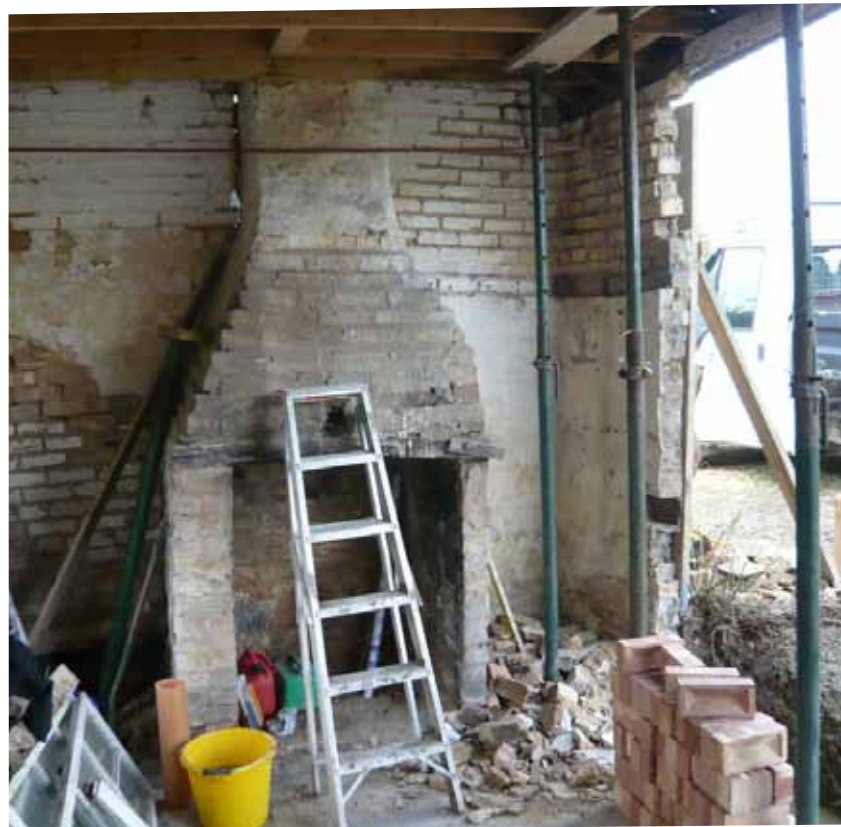
Right **Uncovering the hidden chimney**

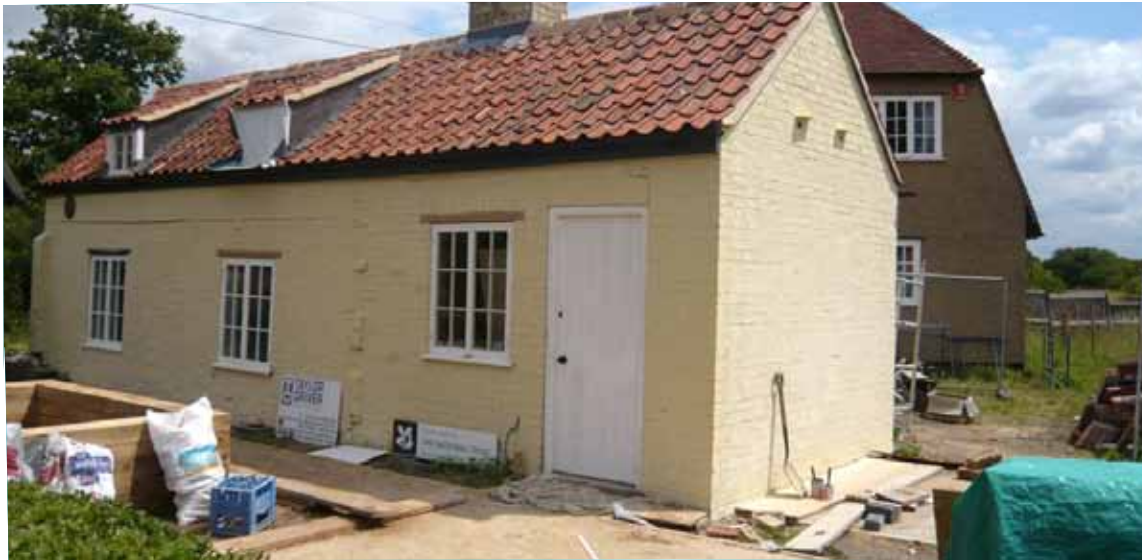
Above **Nearing completion, raised dragonfly pond in the foreground**

■ The garden to the building was of rough grass. A pond was dug to the south of the building and a raised, wheelchair accessible pond created from Oak sleepers and a butile liner outside the front door to act as an education pond. The remainder of the garden was planted with flower and herb borders and managed to encourage dragonflies and other wildlife.

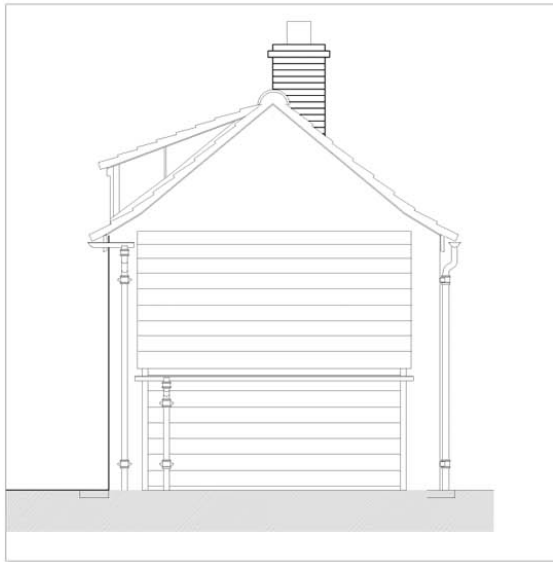
1 SOUTH WEST ELEVATION  
901 - 52

See structural engineer's information regarding ground conditions and below ground proposals; Base for timber framed store also to be as S.E.'s recommendations.

External Walls: remove existing paint; repaint in a NHL2 lime mortar; repaint in a lime based system e.g. Pozilime

Roof Finish: remove existing roof paniles; select best to refurbish north west pitch and supply new to match for the south east pitch

Store: feather edged rough sawn boards fixed on 100 x 50mm studs at 450mm c/s colour of boards TBA; slab base as SE specification; Roof of store to receive matching paniles as main building with pitch of 34deg

Chimney 1: remove existing paint; repaint in a NHL2 lime mortar; insert bedjoint reinforcement as directed by SE; locate a high and low level terracotta 225 x 225mm air brick; repaint as dwelling

Chimney 2: remove existing paint; repaint in a NHL2 lime mortar; repaint in a lime based system e.g. Pozilime; supply and locate 2No clay chimney pots and make good haunching

Heating: Office area to be heated by thermostatically controlled electric convector heater. Exhibition area to have wood burning stove as Stovax Stockton 5 guarded by traditional fire guard fixed to brick returns. Flue from stove to be connected to metal plate with accessible cleaning point on soffit of chimney

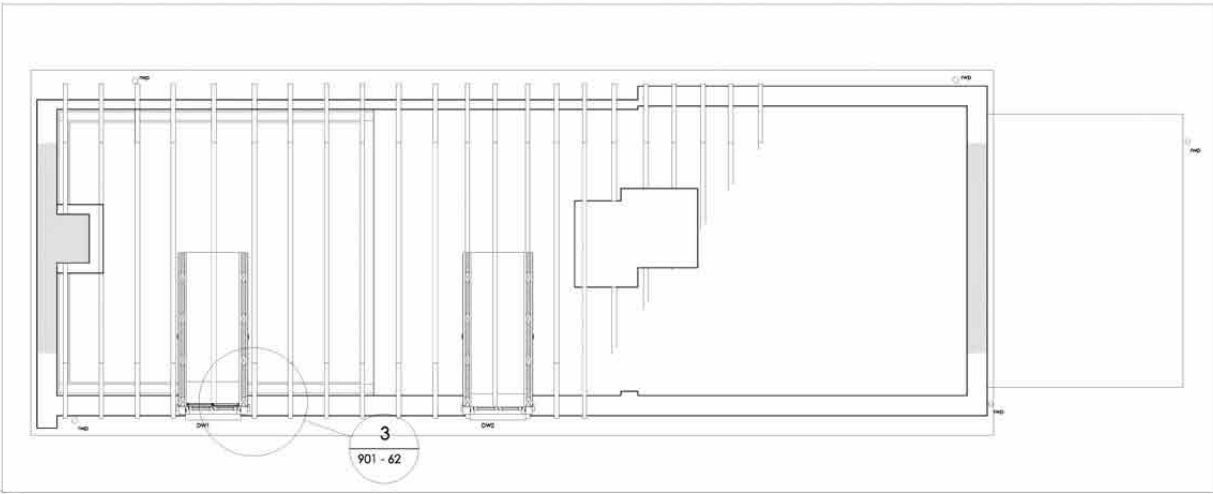
1  
901 - 51  
FIRST FLOOR PLAN

Floor: 120 x 19 t+g square edge Douglas Fir boarding nailed to new timber 100 x 45mm floor joists supported on slate pads with 90mm thick Rockwool Flexi insulation between joists  
NB P/A = 1.33 for office area

New internal walls: 100 x 50mm new timber stud walls separated from existing external wall with impreg s.w. spacers and Tyvek Reflex breather membrane with internal 19mm ext grade plywood and 12.5mm plasterboard and skim to improve U-value to 0.3

Ceilings: ceiling joists as existing but with 100mm rockwool flexi between joists and 100mm overlay across joists to achieve a U-value of 0.23. Internal ceiling finish to be 12.5mm plasterboard and skim.

Dormers: side cheeks with external face of code 6 lead; class A building paper; 19mm ext quality plywood; 50mm Celotex insulation; vapour check plasterboard and skim

Door ED1: framed and boarded with 35mm Celotex insulation between inner and outer faces

Windows: new timber framed opening casements with 'Storm' secondary glazing set into window reveal
